REPORT OF FATAL COAL OUTBURST(BUMP) ACCIDENT
DUTCH CREEK NO. 1 MINE
MID-CONTINENT COAL AND COKE COMPANY
REDSTONE, PITKIN COUNTY, COLORADO

October 3, 1969

I. J. Ratliff
Coal Mine Inspector(Roof Control Specialist)

J. Freeman
Coal Mine Inspector Supervisor

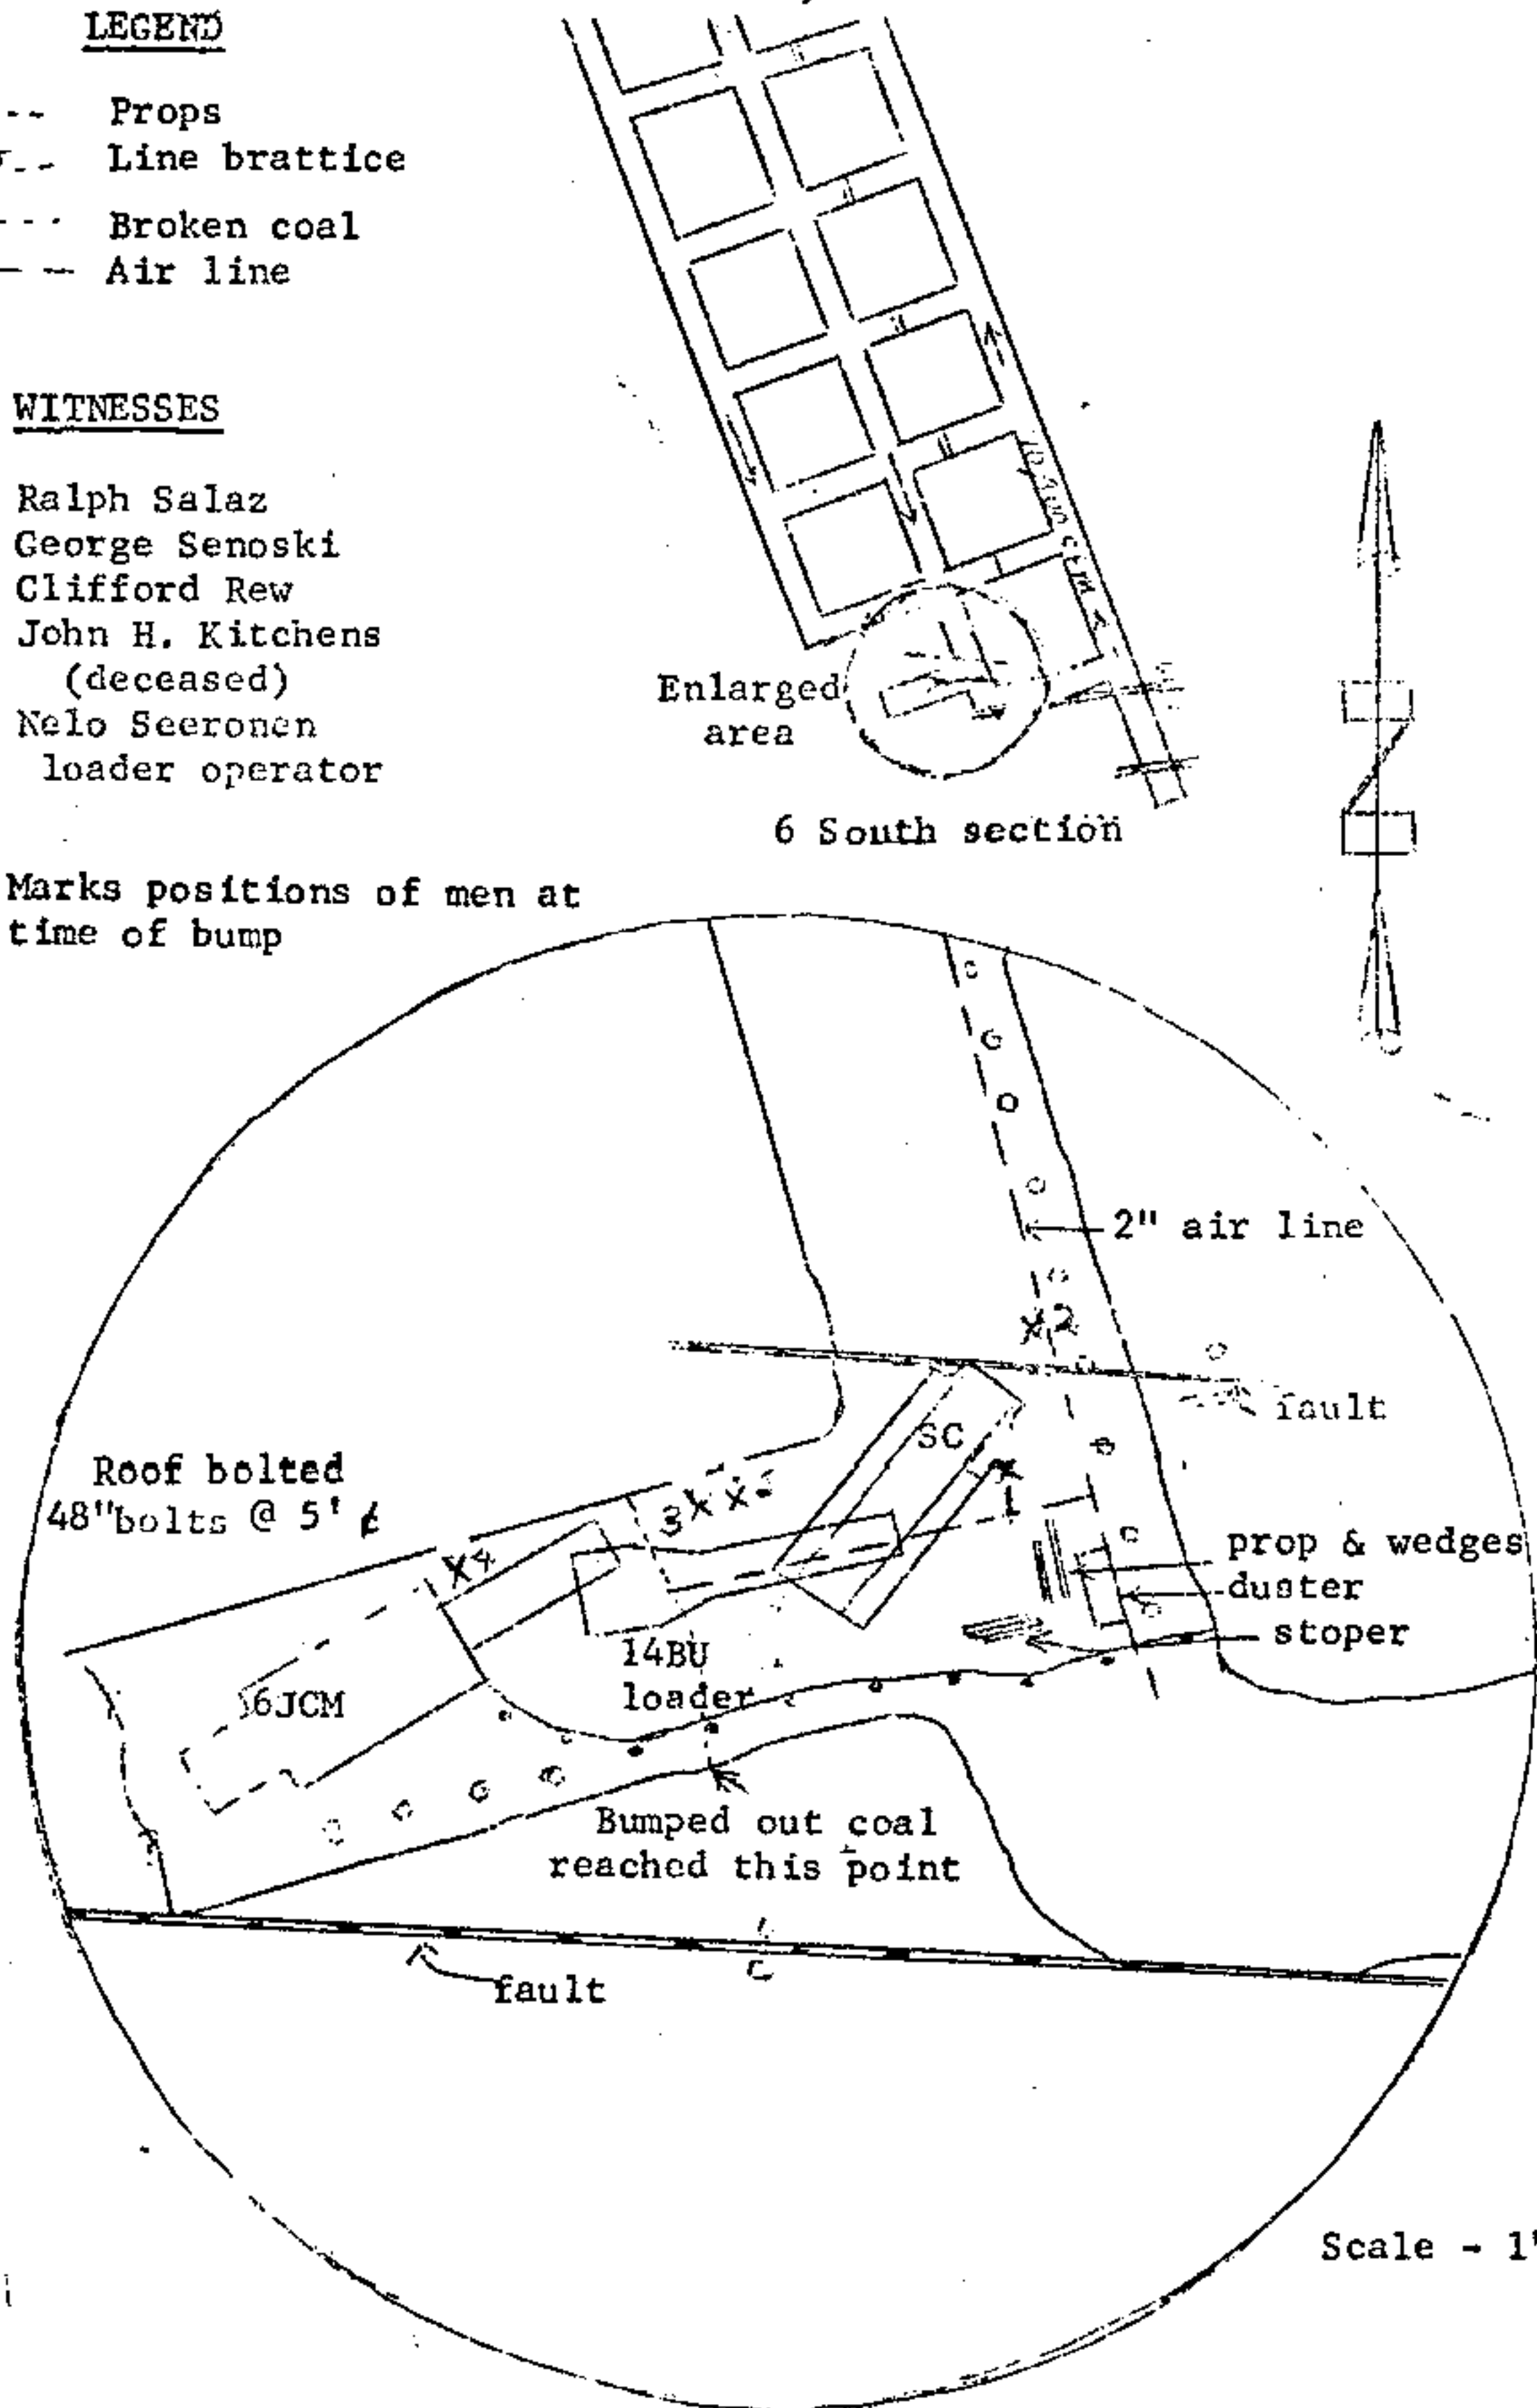
FATAL COAL OUTBURST(BUMP) ACCIDENT
 DUTCH CREEK NO. 1 MINE
 MID-CONTINENT COAL AND COKE COMPANY
 REDSTONE, PITKIN COUNTY, COLORADO
 October 3, 1969

X - Marks positions of men at
 time of bump
